Manhole Inspection Summary

Manhole # S21EE2018MH

Location Address: **5727 FALLS RD**

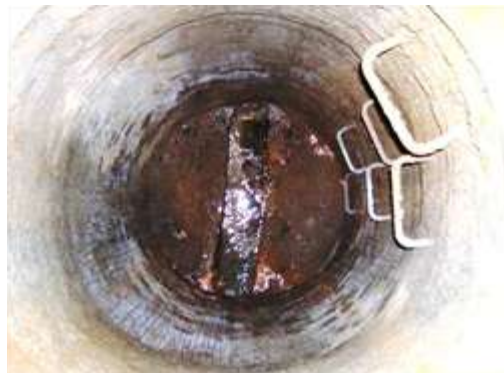
Top View

Evidence of surcharge - Bench debris.
Channel debris.

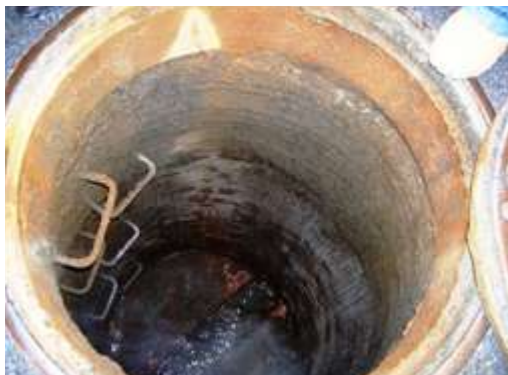
Defect

Frame leaks. Adjustment and Barrel
infiltration - other side.

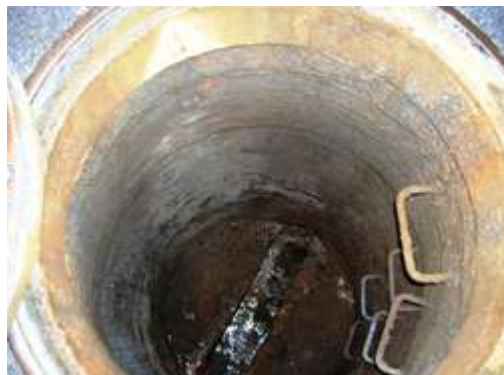
Defect

Frame leaks. Adjustment and Barrel
infiltration.

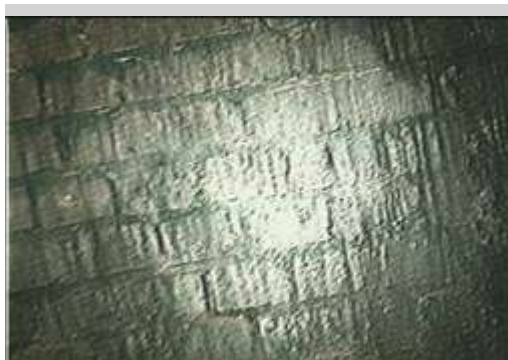
Defect

Barrel infiltration.

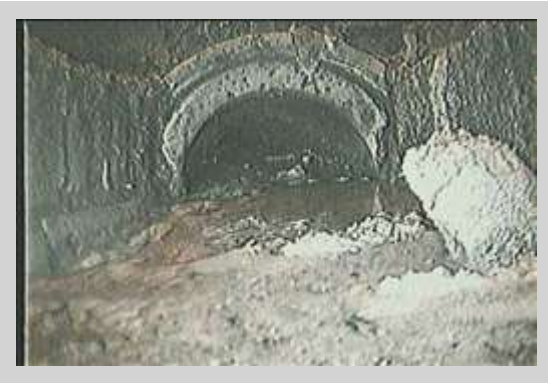
10 in. Circular Gravity Sewer Pipe Out @ 12 O'Clock

Channel debris.

Deposits: ☐ None ☒ **Mud** ☐ Sludge ☒ **Debris** ☒ **Grease**

Silt Depth: **3** (in.) Deposits Extent: **Medium**

Infiltration: **None** Pipe Seal Cond: **Cracked**

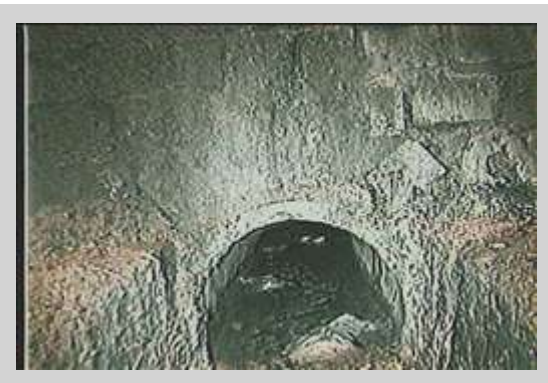
10 in. Circular Gravity Sewer Pipe In @ 6 O'Clock

Deposits: ☐ None ☒ **Mud** ☐ Sludge ☒ **Debris** ☒ **Grease**

Silt Depth: **2** (in.) Deposits Extent: **Light**
